SUBSIDIES FOR MONITORING RIVERCROSSINGS AND FISHING BOAT POINTS ON A SECTION OF THE APA RIVER, AT THE BRAZILIAN/PARAGUAYAN BORDER

Summary

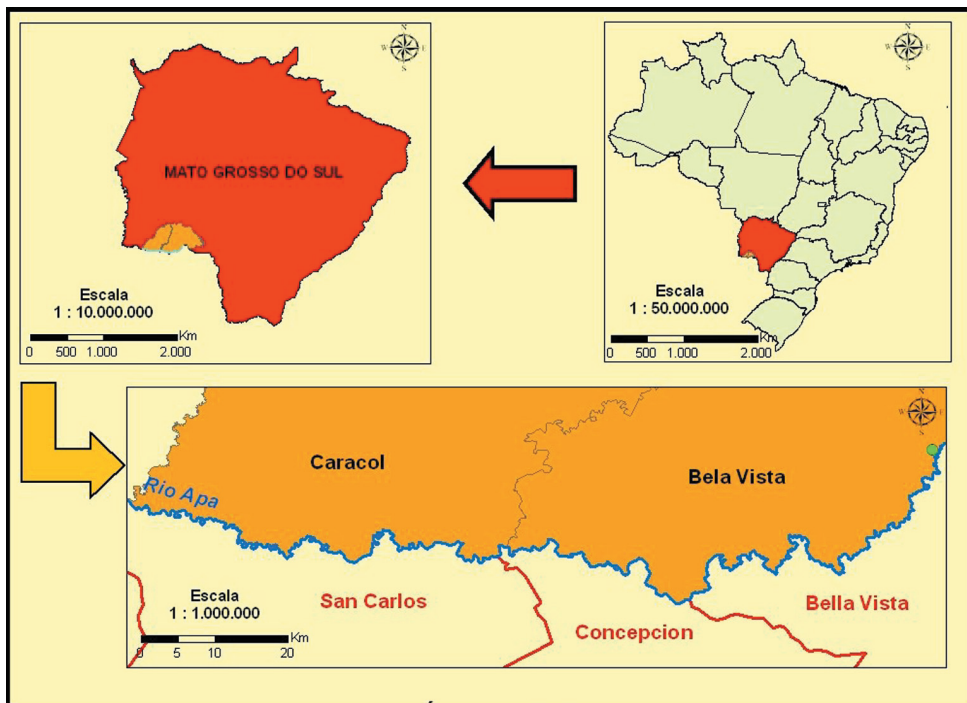
Figure 1 - Locale of the studied portion on Apa river, municipalities of Bela Vista and Caracol in the State of Mato Grosso do Sul

Figure 1 shows the section of the Apa river being studied, starting in the city of Bela Vista till the Perdido river, including the municipalities of Bela Vista and Caracol in the State of Mato Grosso do Sul (Brazil) and *Bella Vista, Concepción* and *San Carlos* (Paraguay).

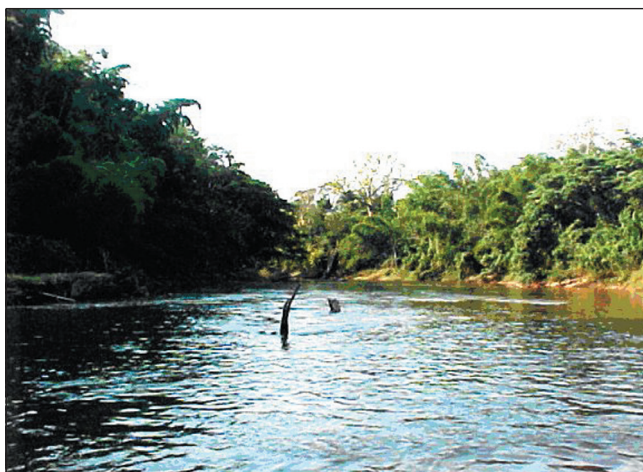
Picture 1 - Underwater tree branch

The Apa river is presently suffering strong silting in several sections of its extension. The amount of sediments which came from its margins is concentrated in those points where the river is much shallower, making the navigation even more difficult. The huge amount of tree trunks stuck on the river bed is very dangerous for smaller boats, as seen on picture 1.

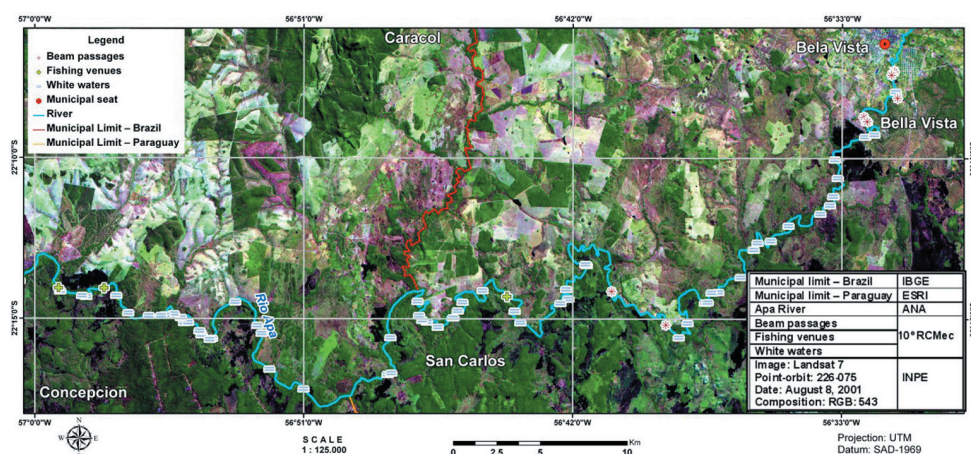
Figure 2A - Characterization map of the Apa river, from the point outside the city of Bela Vista, MS, up to longitude 57°0'0"W

Sixty-two chute portions were mapped on the studied section, which difficulties the navigation practically year-round. We also mapped nine fishing venues characterized on table 1 and 12 ford crossings on both Paraguayan and Brazilian sides. All points mapped are represented on figures 2A, 2A1 and 2B, 2B1.

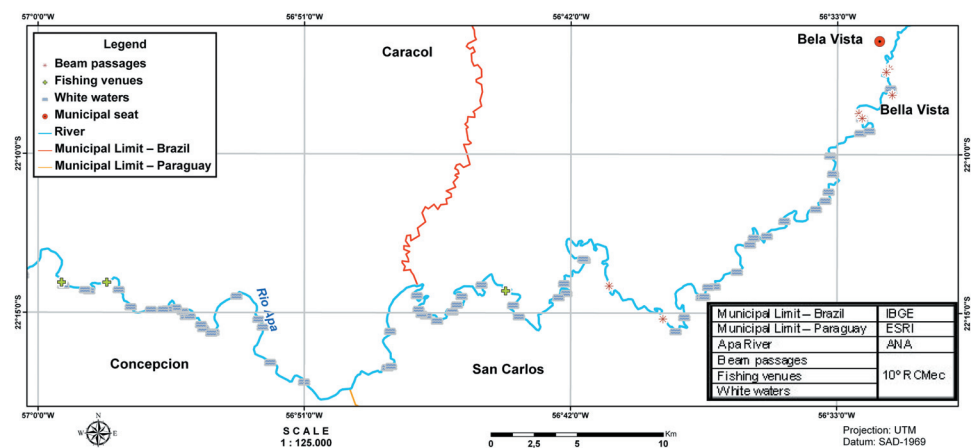
Figure 2A1 - Characterization map of the Apa river, without orbital imagery, from the point outside the city of Bela Vista, MS, up to longitude 57°0'0"W

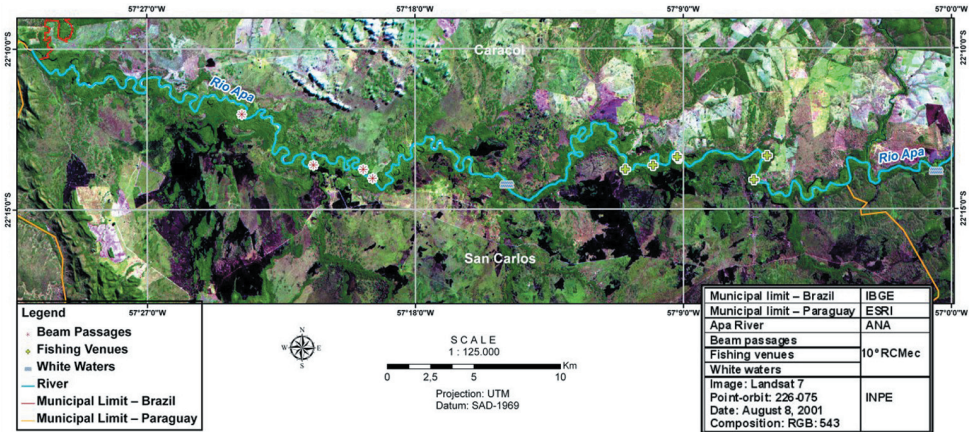
Figure 2B - Characterization map of the Apa river, from longitude 57°0'0"W to the Perdido River, municipality of Caracol, MS

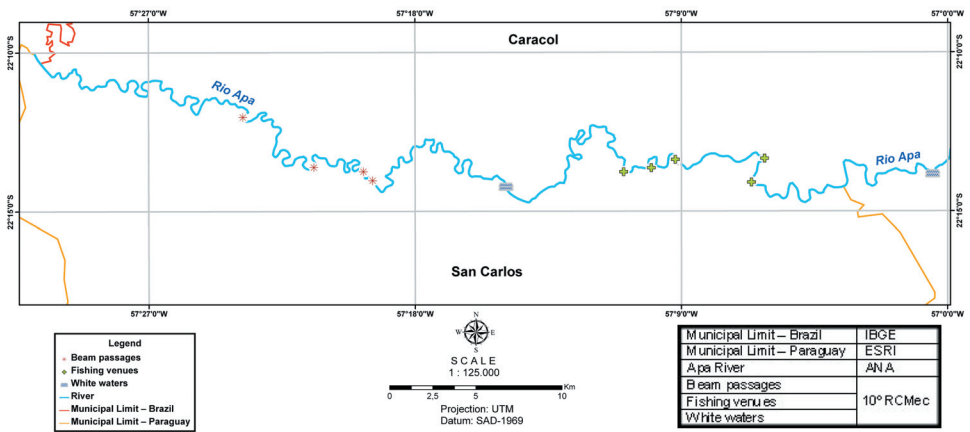
Figure 2B1 - Characterization map of the Apa river, without orbital imagery, from longitude 57°0'0"W to the Perdido River, municipality of Caracol, MS

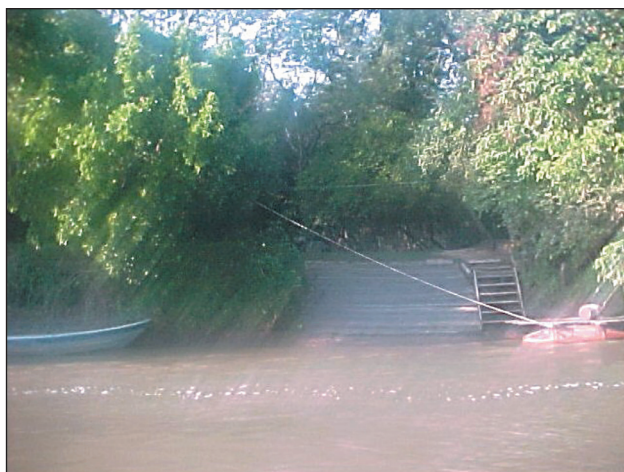
Picture 2 - Baía Negra Fishing Venue, Brazilian margin

Some areas where fishing venues are placed are highly damaged due to the construction of facilities in the Permanent Preservation Areas as seen on figure 2.

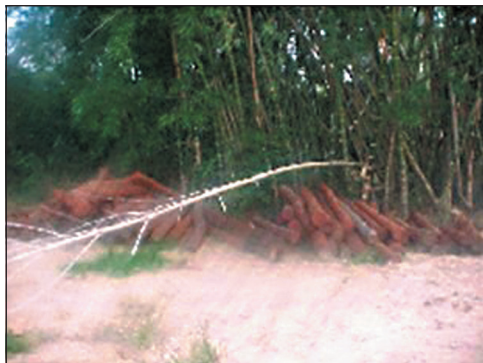
Picture 3 - Beam passage, with piled up peppertree on the Paraguayan margin

Considering these observations, a constant monitoring, inspections and control of the ford crossings as seen on figure 3, where peppertree timber is piled on the Paraguayan margin of the river ready to be shipped by boat to cross to the Brazilian margin; and fishing venues. Such places must be recovered according to the present legislation.

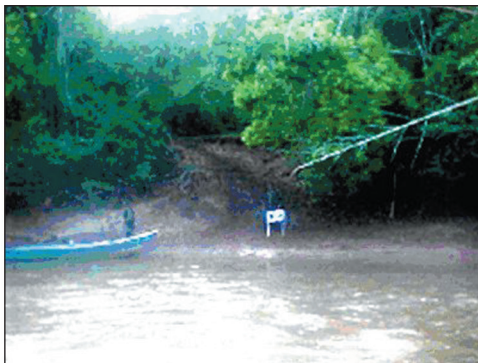
Picture 4 - Beam passage with recent livestock crossing tracks on the Brazilian margin

The river crossing of bovines, besides risking the health of the herds from both Brazil and Paraguay, are contributing to the silting of the riverbed, due to the livestock trampling in the margins as seen on figure 4. The picture was taken on the Brazilian margin, a few minutes after crossing of a bovine herd from Paraguay. The Brazilian margin was wet, with recent paw prints from the animals.
